Manhole Inspection Summary

Manhole # S45I__034MH

Location Address: **300 gough st**

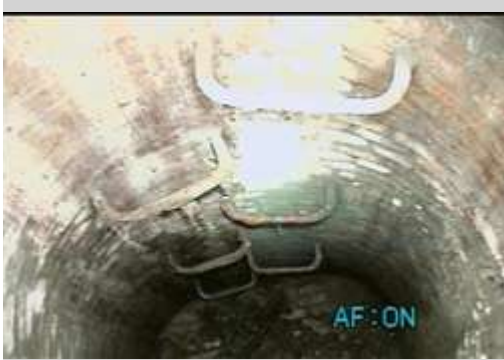
Defect 1

Count: **6** Missing: **0** ☒ **Corroded**

corroded stairs

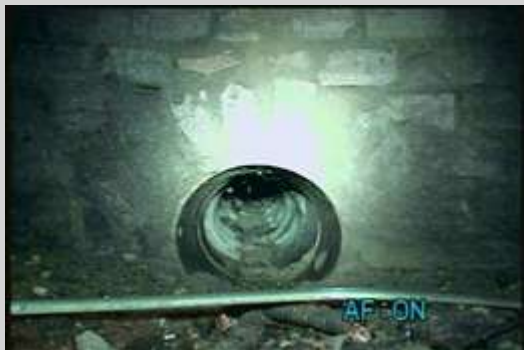
12 O'Clock Outflow

8 in. Circular Gravity Sewer
Pipe Out @ 12 O'Clock

Deposits: ☐ None ☐ Mud ☐ Sludge ☒ **Debris** ☐ Grease

Silt Depth: 1 (in.) Deposits Extent: **Light**
